Graduate Candidate	Dominik Amstad
Examiner	Prof. Dr. Andreas Häberle
Co-Examiner	Dr. Gerhard Kleiss, Kleiss Consulting, Bonn, NW
Subject Area	Electric solar technology
Project Partner	Prof. Ricardo Rüther, PhD., Universidade Federal de Santa Catarina - UFSC, Florianópolis, Santa Catarina, Brasil

Infrared Imaging of Thin Film PV Plants Using Aerial Inspection

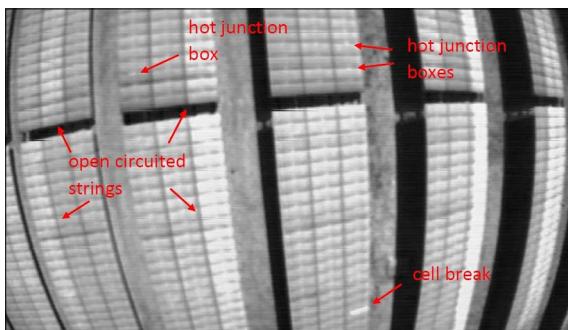
Infrared image taken by the drone from 20 m altitude shows different faults in the PV plant in Tubarão

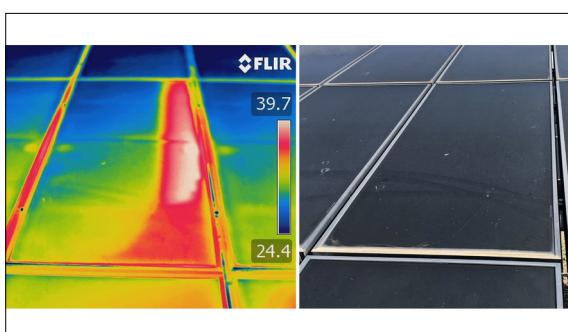
Infrared image (left) taken by the handheld camera shows a hot spot caused by broken cells (right)
