# GPR chloride inspection of a RC bridge deck slab followed by an examination of the results

J. Hugenschmidt, F. Wenk  
Rapperswil University of Applied Science  
Oberseestrasse 10, 8640 Rapperswil  
Switzerland  
johannes.hugenschmidt@hsr.ch

**Abstract**— Chlorides applied to roads and bridges for de-icing can cause serious damage to concrete structures. On bridge deck slabs, there is usually a waterproofing membrane to prevent the ingress of water and chlorides into the concrete. If the waterproofing is damaged, the protection is insufficient and chloride ions and humidity penetrate into the concrete causing corrosion of steel reinforcing bars. This can finally result in a failure of the structure.

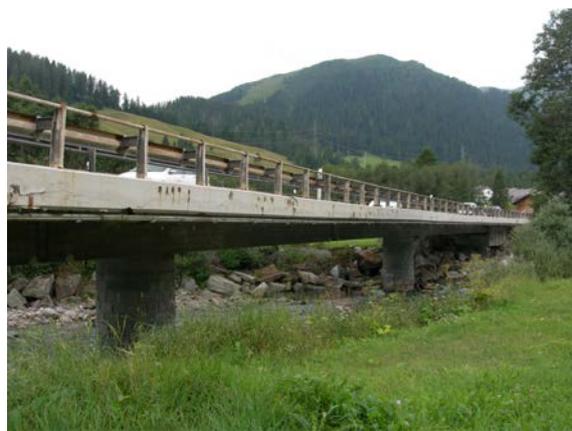
Figure 1: The selected bridge on National Road 13

The first step was the selection of a suitable bridge. For this purpose, three criteria were defined. The bridge should allow for an intensive probing in about 50 locations and the probing should be carried out in 2013. In addition, a chloride contamination was considered as desirable. The first two criteria were defined as requirements, the chloride contamination was difficult or impossible to predict. The required intensive probing led to the conclusion that only a bridge designated for demolition was suitable. This, together with the need to carry out the probing in 2013, led to a very limited choice of objects. Finally, a bridge on National Road Nr. 13 near Splügen, Grisons, Switzerland was selected. The bridge deck had a length of 79 m, the width was 10.0 m. The selected bridge is presented in Figure 1. It was demolished in autumn 2013.

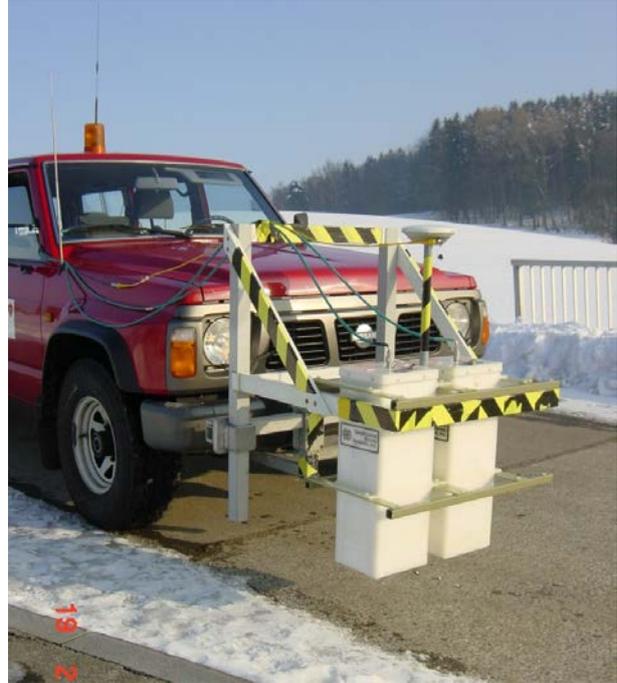
**Figure 2: Mobile acquisition system**

Data were acquired in April 2013 using a mobile acquisition system based on a GSSI-SIR20 radar unit, a pair of model 4205 horn antennas, a Trimble model 5700 RTK GPS system and numerous accessories (Figure 2). Before data acquisition, lines parallel to the bridge axis were computed and later used for navigation. The distance between those acquisition lines was 0.5 m. Two different antenna orientations were used. In configuration 1 the electric field was orthogonal to the bridge axis, in configuration 2 it was parallel. The acquisition parameters can be summarized as follows:

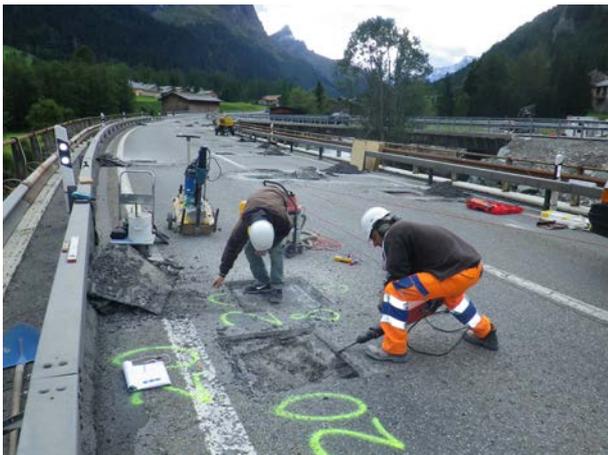
**Figure 4: Probing on bridge**

The situation during the probing is presented in Figure 4, one location after the completion of the probing is shown in Figure 5.

- Mark probing position of surface using an RTK-GPS system
- Open a window of 0.8 x 0.8 m
- Remove sealing
- Measure pavement thickness (including sealing)
- Mark rebar position using electromagnetic device and magnet
- Measure self-potential in six locations
- Remove concrete to expose rebar
- Measure concrete cover of rebar
- Measure rebar diameters
- Secure and seal concrete specimen for measurement of moisture in laboratory
- Inspect rebar for corrosion
- Carry out carbonation test
- Take two cores for chloride analysis in laboratory
