Long-term experience with cathodic protection of reinforced concrete structures

Felix Wenk

Helbling Beratung + Bauplanung AG, Hohlstrasse 614, Zurich, Switzerland
felix.wenk@helbling.ch

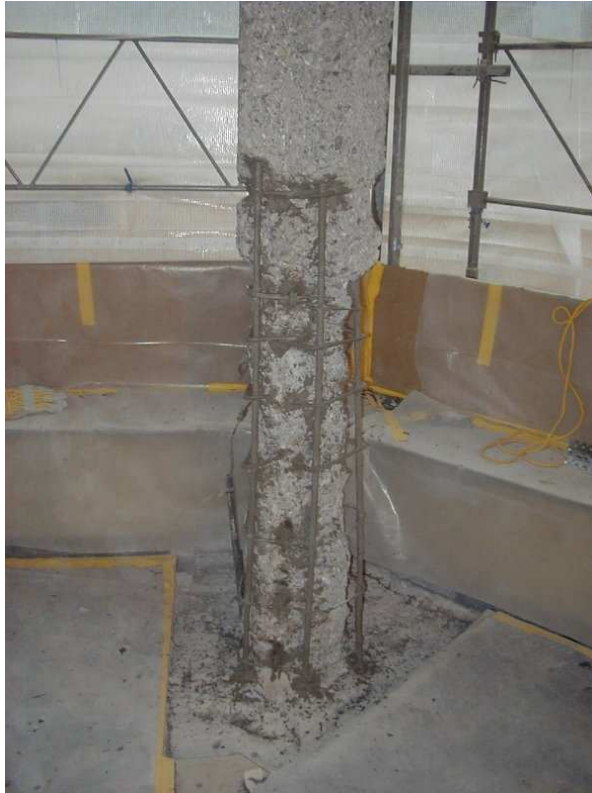
Fig. 1: Support during the repair

- Weakening of the structure, risk of cracks during the repair (Fig. 1)
- Bond problems between old and new concrete (Fig. 2)
- Macro element formation between the reinforcement in old and new concrete (Fig. 3)

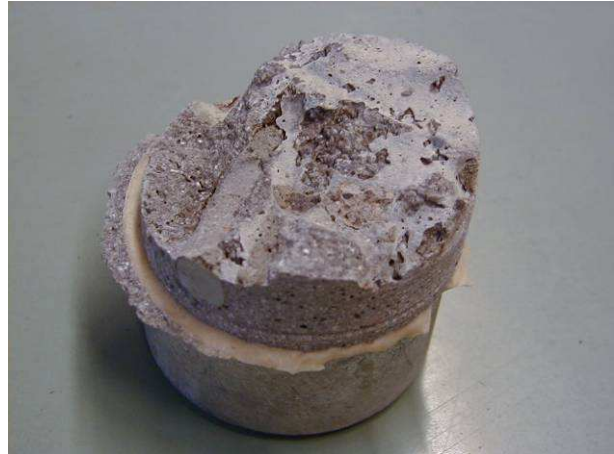
Fig 2: Bond problems

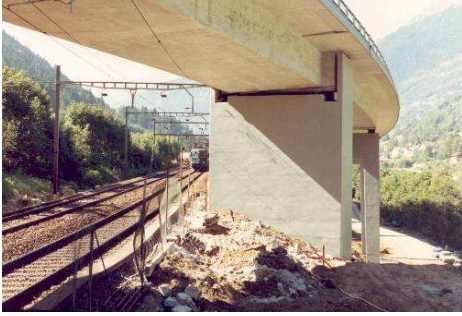
Fig 4: Bridge in Rodi-Fiesso

<p>Structure: Bridge in Rodi-Fiesso Commissioning: 1988 Under protection: Abutments and supports Surface area protected: 287 m² Number of supply zones: 7 Voltage supply: 3.8 V Average protective current density: 11 mA/m² concrete Average anode current density: 44 mA/m² Reference electrodes: 7 holes for CSE Test coupons: 7 Power source: 12 V/8.3 A (output regulated)</p>

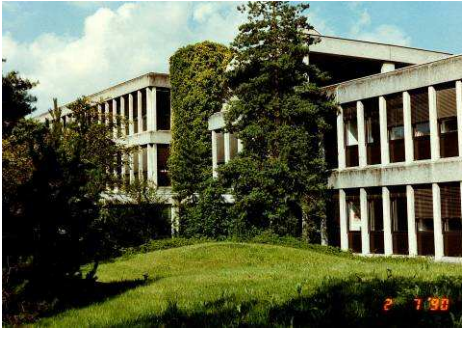
Fig 5: Segelhof in Dättwil

<p>Structure: Segelhof office building in Dättwil Commissioning: 1991 Under protection: Façade supports Surface area protected: 185 m² Number of supply zones: 4 Voltage supply: 2.4 V Average protective current density: 6 mA/m² concrete Average anode current density: 23 mA/m² Reference electrodes: None Test coupons: None Power source: 48 V/3 A (output regulated)</p>

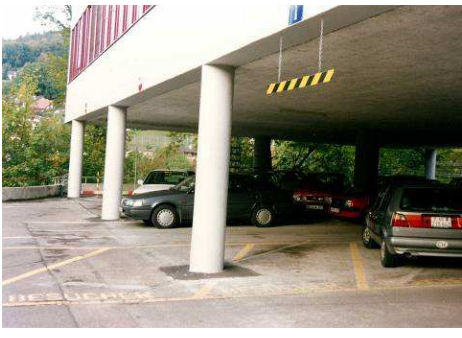
Fig 6: Römerstrasse covered parking lot

<p>Structure: Römerstrasse covered parking lot in Baden Commissioning: 1991 Under protection: Supports Surface area protected: 237 m² Number of supply zones: 4 Voltage supply: 2.2 – 3.1 V Average protective current density: 2 mA/m² concrete Average anode current density: 8 mA/m² Reference electrodes: None Test coupons: None Power sources: 12 V/10 A (output regulated)</p>

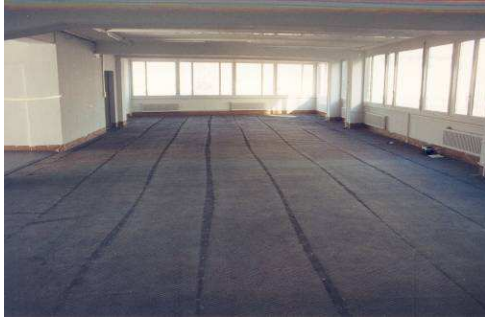
Fig 7: Office building in Zurich

Structure: Hohlstrasse office building in Zurich
Cause of damage: Chlorides from mineral wood flooring
Commissioning: 1992
Under protection: Ceiling structure
Surface area protected: 399 m²
Number of supply zones: 2
Voltage supply: 2.8 V
Average protective current density: 2 mA/m² concrete
Average anode current density: 9 mA/m²
Reference electrodes: 4 holes for CSE
Test coupons: None
Power source: 24 V/25 A (output regulated)

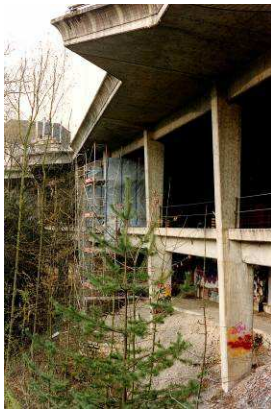
Fig 8: Supports at the station square

Structure: Station square in Baden
Commissioning: 1992
Under protection: Supports
Surface area protected: 97 m²
Number of supply zones: 3
Voltage supply: 3.3 V
Average protective current density: 8 mA/m² concrete
Average anode current density: 30 mA/m²
Reference electrodes: 6 holes for CSE
Test coupons: None
Power source: 12 V/10 A (output regulated)

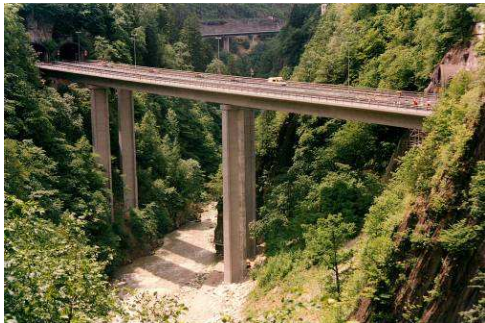
Fig 9: Intschi bridge near Amsteg

Structure: Intschi bridge near Amsteg
Commissioning: 1993 (not in use since 1999, trial)
Under protection: Support
Surface area protected: 180 m²
Number of supply zones: 3
Voltage supply: 1.2 V
Average protective current density: 2 mA/m² concrete
Average anode current density: 7 mA/m²
Reference electrodes: 10 (Ag/AgCl)
Macrocells: 6

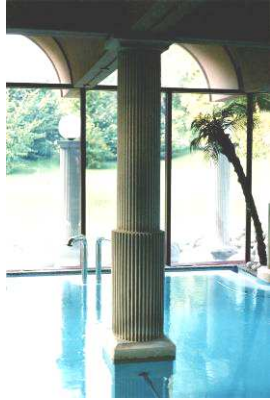
Fig 10: Saline bath in Regensdorf

Structure: Fitness park in Regensdorf
Commissioning: 1993 (conversion in 2004)
Under protection: Supports in the saline bath
Surface area protected: 6 m²
Number of supply zones: 1
Voltage supply: 1.6 V
Average protective current density: 3 mA/m² concrete
Average anode current density: 13 mA/m²
Reference electrodes: None
Test coupons: None

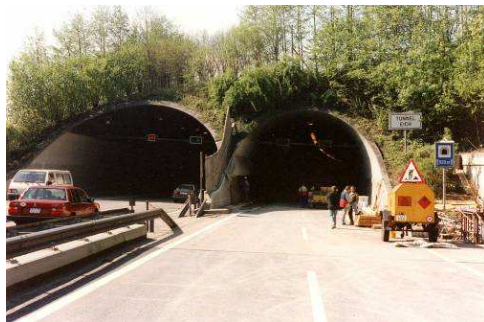
Fig 11: Eich tunnel near Eich

Structure: Eich tunnel near Eich
Commissioning: 1994
Under protection: Tunnel walls
Surface area protected: 2,500 m²
Number of supply zones: 12
Voltage supply: 1.1 to 1.7 V
Average protective current density: 3 mA/m² concrete
Average anode current density: 12 mA/m²
Reference electrodes: 24 (Ag/AgCl)
Test coupons: 12
Power sources: 12 V/10 A (output regulated)

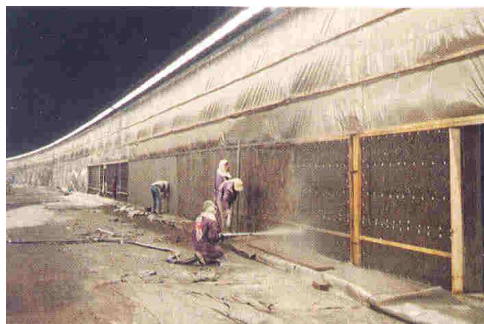
Fig 12: Gotthard tunnel entrance

Structure: Gotthard tunnel entrance near Göschenen
Commissioning: 1995
Under protection: Tunnel walls, supports
Surface area protected: 2,860 m²
Number of supply zones: 8
Voltage supply: 1.1 to 2.9 V
Average protective current density: 3 mA/m² concrete
Average anode current density: 13 mA/m²
Reference electrodes: 50 (Ag/AgCl)
Test coupons: 28
Power sources: 12 V/10A (voltage regulated)

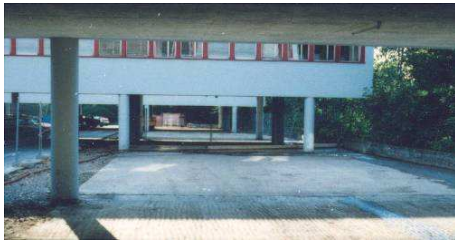
Fig 13: Parking garage in Baden

Structure: Römerstrasse covered parking lot in Baden

Under protection: Parking deck

Surface area protected: 903 m²

Voltage supply: 1.1 V

Reference electrodes: 7 (Ag/AgCl)

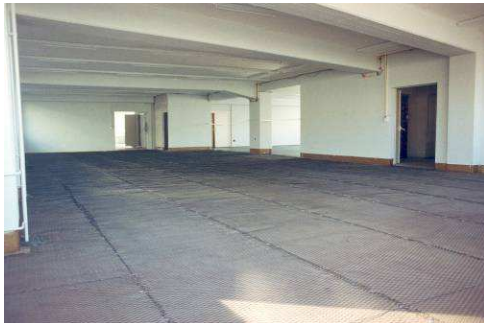
Fig 14: Office building in Zurich

Structure: Hohlstrasse office building in Zurich

Cause of damage: Chlorides from mineral wood flooring

Under protection: Ceiling structure

Surface area protected: 380 m²

Voltage supply: 3.3 V

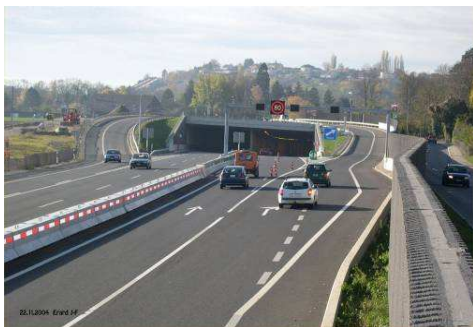
Fig 15: A5 highway tunnel

Structure: Highway tunnel near Auvernier

Under protection: Tunnel walls

Surface area protected: 2,500 m²

Voltage supply: 2.5 to 3.5 V

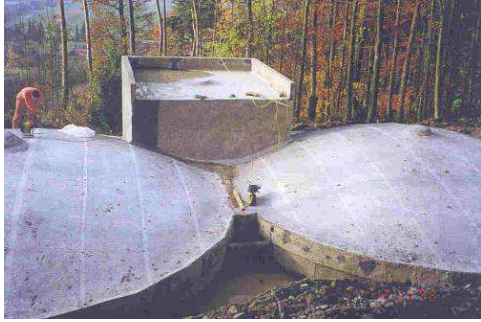
Fig 16: Drinking water container in Arnen near Arnen

Structure: Drinking water container in Arnen near Kerzers
Commissioning: 1998
Under protection: Ceiling
Surface area protected: 77 m²
Number of supply zones: 2
Voltage supply: 1.9 V
Average protective current density: 9 mA/m² concrete
Average anode current density: 36 mA/m²
Reference electrodes: 4 (Ag/AgCl)
Test coupons: 4
Power sources: 12 V/2 A (potentiostatically regulated)

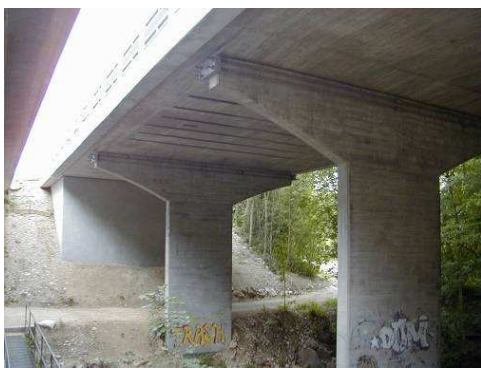
Fig 17: Siggern bridge near Attiswil

Structure: Siggern bridge near Attiswil
Commissioning: 2003
Under protection: Abutments, truss heads and lane intersection
Surface area protected: 280 m²
Number of supply zones: 10
Voltage supply: 1.4 V
Average protective current density: 5 mA/m² concrete
Average anode current density: 21 mA/m²
Reference electrodes: 8 (titanium)
Test coupons: 8
Power source: 12 V/2 A (potentiostatically regulated)

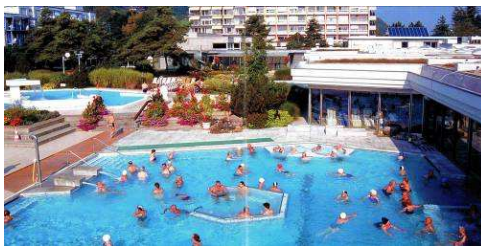
Fig 18: Rheumatism clinic in Zurzach

Structure: Rheumatism clinic in Zurzach
Commissioning: 2003
Under protection: Ceiling of the heat storage basin
Surface area protected: 150 m²
Number of supply zones: 1
Voltage supply: 1.4 V
Average protective current density: 12 mA/m² concrete
Average anode current density: 48 mA/m²
Reference electrodes: 2 (titanium)
Test coupons: 2
Power source: 12 V/2 A (output regulated)

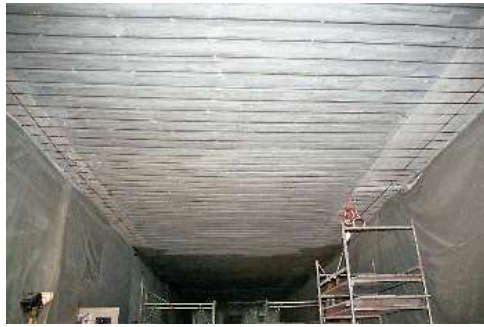
Fig 19: Palestra Polisportiva

Structure: Palestra Polisportiva in Lugano
Commissioning: 2004
Under protection: Hurdis ceiling
Surface area protected: 175 m²
Number of supply zones: 3
Voltage supply: 2.5 V
Average protective current density: 3 mA/m² concrete
Average anode current density: approx. 25 mA/m²
Reference electrodes: 6 (titanium)
Test coupons: 6
Power source: 12 V/10 A (output regulated)

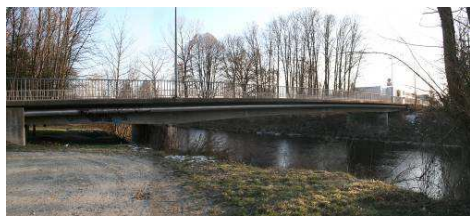
Fig 20: Bridge over the river Emme near Aefligen

Structure: Bridge over the river Emme near Aefligen
Commissioning: 2006
Under protection: Truss heads, lane intersections and kerbstones
Surface area protected: 122 m²
Number of supply zones: 8
Voltage supply: 1.4 to 2.0 V
Average protective current density: 10 mA/m² concrete
Average anode current density: 50 mA/m²
Reference electrodes: 8 (titanium)
Test coupons: 10
Power source: 12 V/2 A (potentiostatically regulated)

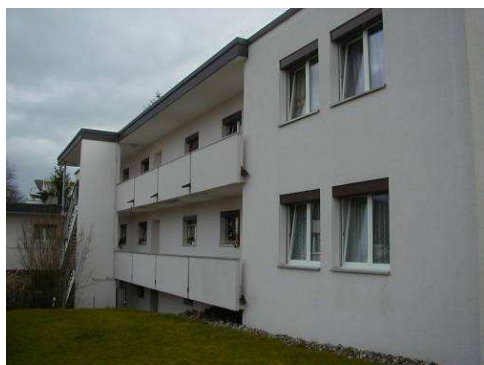
Fig 21: Apartment building in Adliswil

Structure: Apartment building in Adliswil
Commissioning: 2007 (currently being processed)
Under protection: Covered passages
Surface area protected: 60 m²
Number of supply zones: 3
Reference electrodes: 3 (titanium)
Test coupons: 3
Power source: 10 V/10 A (voltage regulated)

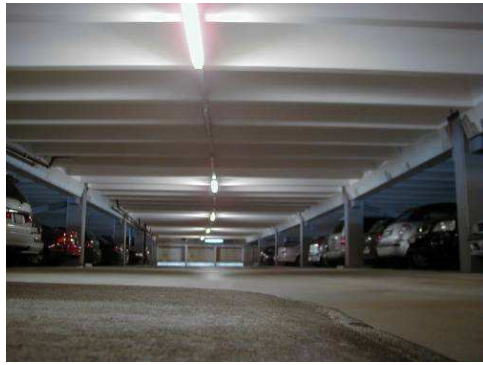
Fig 22: Airport parking garage

Structure: Parking garage P6 at Zurich Airport
Installation: 2007 (currently being processed)
Under protection: Parking deck
Surface area protected: 770 m²
Number of supply zones: 3
Reference electrodes: 6 (titanium)
Test coupons: 6

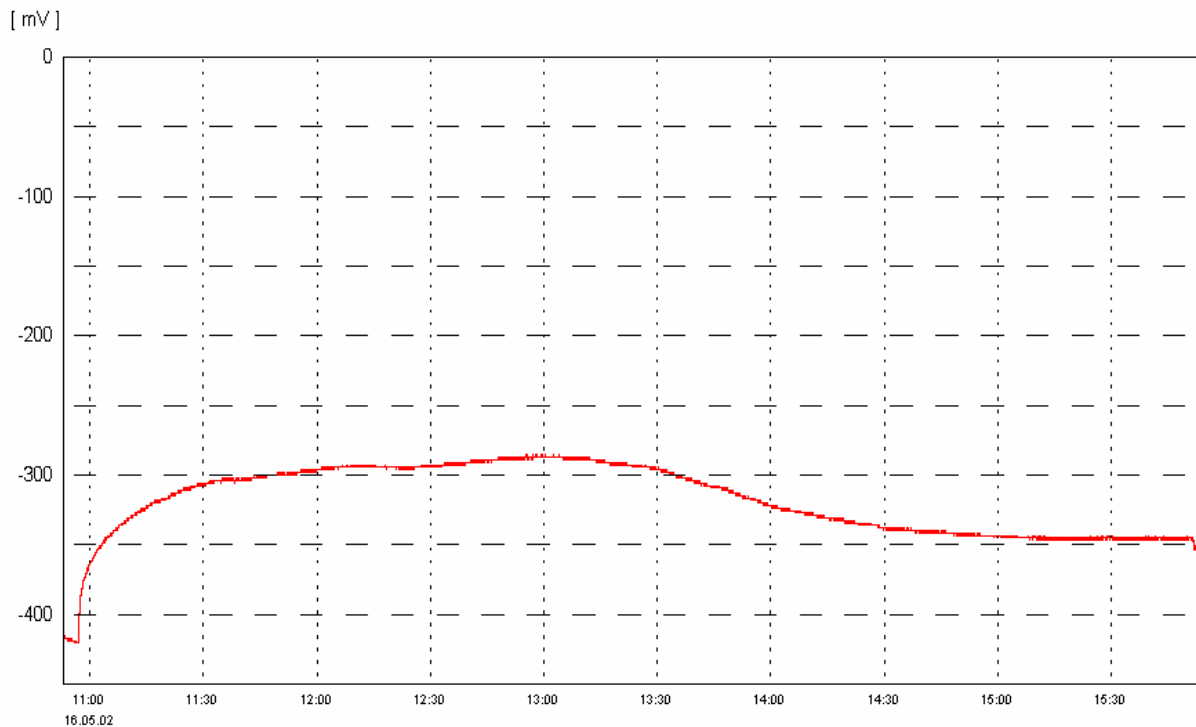
Diagram 2: Measurement of depolarisation with mobile copper/copper sulphate electrodes

So far, the reference electrodes permanently installed have been silver/silver chloride electrodes or electrodes made of oxide-activated titanium. On several occasions, holes have also been drilled into the structure to the depth of the reinforcement layer in order to measure the potentials or the depolarisation using mobile copper/copper sulphate electrodes. Basically, the reference electrodes used up to now have not presented any substantial problems. Even after more than 10 years, permanently embedded reference electrodes continue to perform their intended function. While the electrodes made of oxide-activated titanium do not show a constant potential, they are, however, less expensive and easy to use. However, they meet requirements as the relative potential (drop in potential, rise in potential) is more important in the cathodic protection of reinforced concrete structures than the absolute potential. Some problems were noted when measuring depolarisation with mobile copper/copper sulphate electrodes in existing holes. It appears that drying out or minor displacements caused by vibrations while taking measurements can lead to changes in potential that cause problems (see Diagram 2).
