# Measurement of ropeway tower deformations

## Using Motion Amplification

### Student

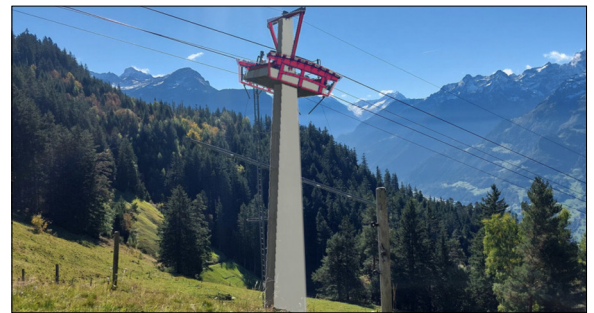
Structural analysis model of tower 5 in it's natural environment  
Own presentment

The measures were done on the towers nr. 2 and 5 of the aerial ropeway 15-ATW Flüelen-Eggberge (Canton of Uri / Switzerland). Tower 2 has a height of about 10 metres, is made from steel and carries rope spans of about 500 m on lower and upper span. Tower 5 has a height of about 12 metres, is made of concrete and carries rope spans of about 50 m on lower and upper span.

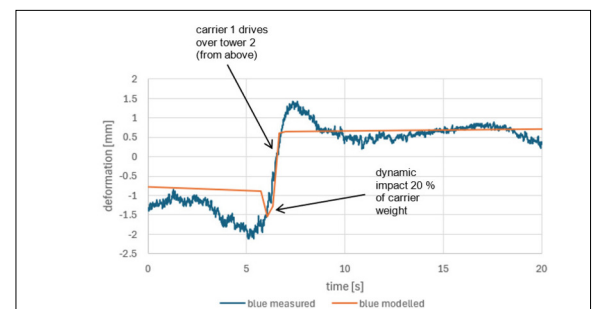
Comparison of the calculated and measured deformation with the Motion Amplification camera at tower 2

To verify the results of the motion amplification camera there were placed magnetic strain gauges on the towers and the expected deformations were calculated with a self-developed rope calculation program and a structural analysis model.
